WELDING INSPECTION REPORT

Resident Engineer: Pursell, Gary **Report No:** WIR-003532 Address: 333 Burma Road **Date Inspected:** 26-Jul-2008

OSM Arrival Time: 700 **Project Name:** SAS Superstructure **OSM Departure Time:** 1730 **Prime Contractor:** American Bridge/Fluor Enterprises, a JV

34-0006 **Bridge No: Component:** Tower/OBG

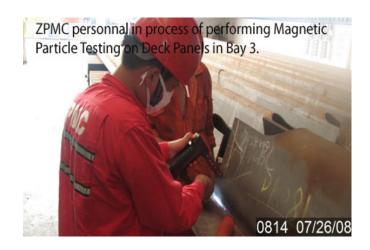
The Quality Assurance Inspector performed 10% random magnetic particle testing verification on Deck Panels. The Quality Assurance Inspector performed the testing on the following Deck Panels; DP-108-001, DP-299-001, DP-432-001, and DP326-002. See Caltrans report TL-6028 Magnetic Particle Test Report, dated July 26, 2008 for additional information.
